Evaluation of the Structural Performance of CTS Rapid Set Concrete Mix®

Lucy P. Priddy, Haley P. Bell, Lulu Edwards,
William D. Carruth, and James F. Rowland

August 2016

Final report

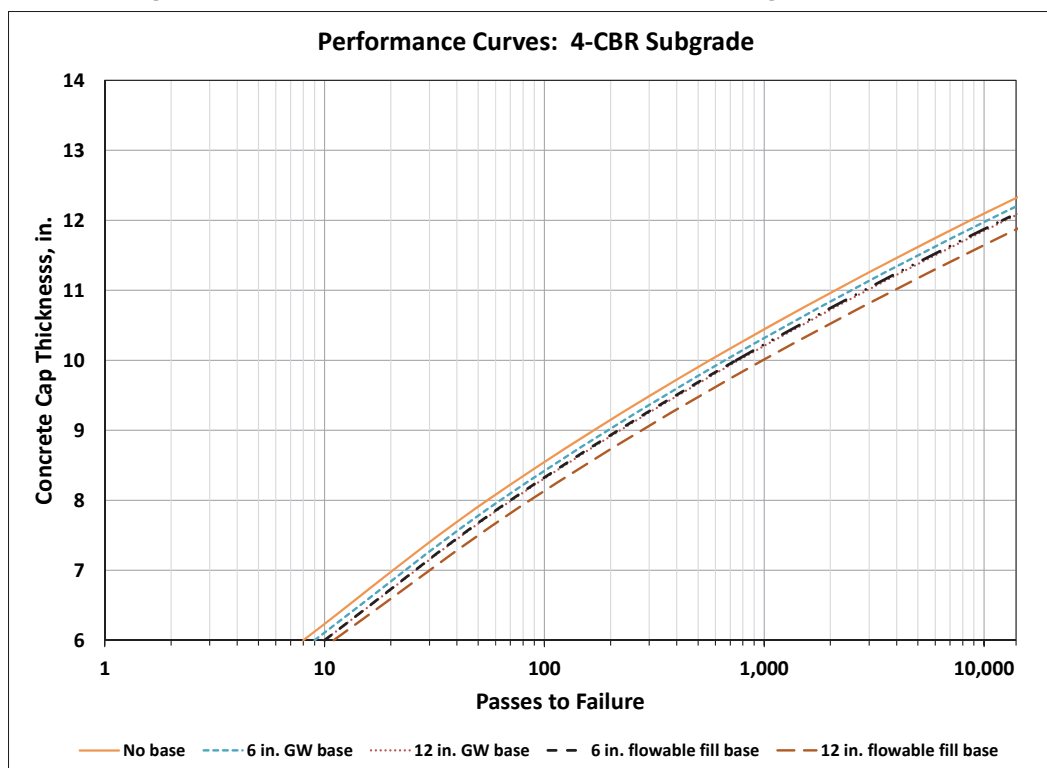
Figure 35. Predicted repair performance for a 4-CBR subgrade (PSeven).

The performance curves for the various pavement structures on a 4-CBR subgrade are presented in Figure 35. These curves take into account all five series of repairs' structures (no base, 6-in.-thick weak base, 6-in.-thick strong base, 12-in.-thick weak base, and 12-in.-thick strong base).

The results shown in Table 11 indicate that the theoretical performance curves shown in Figure 35 underpredict the field performance of all repair series of tests. This would be expected, as design procedures are generally conservative. The mode of failure (spalling versus shattered slab) was also different.

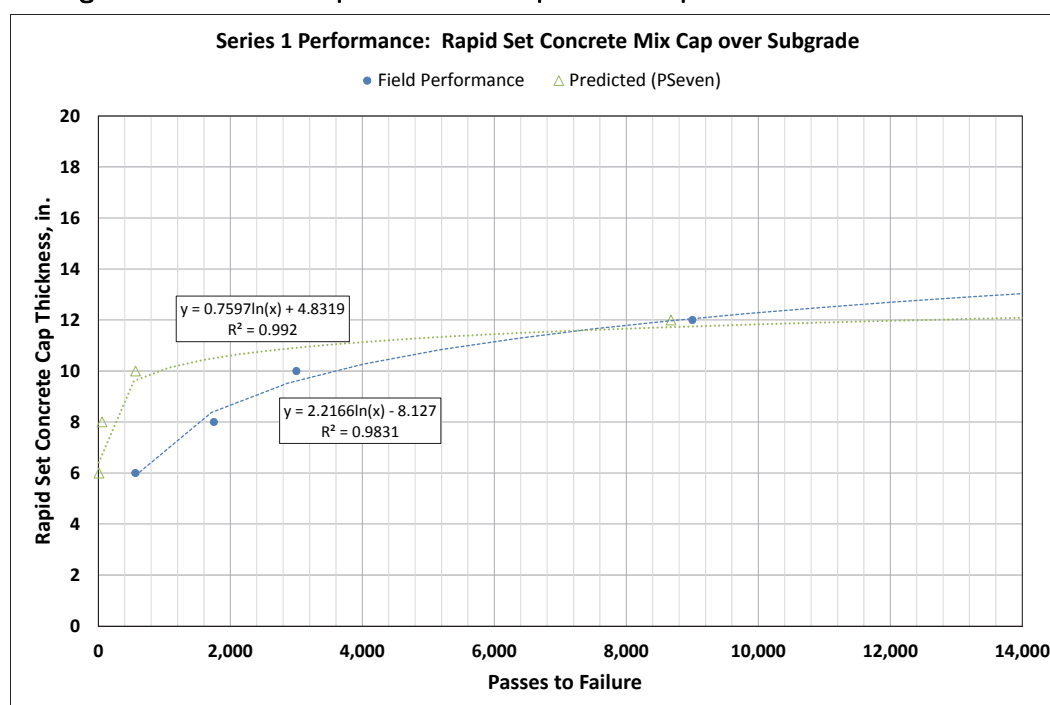
Figure 37. Series 1 field performance and predicted Rapid Set Concrete Mix[®] Curves.

Figure 37 and 38 present the theoretical and performance curves for the Series 1 and 5 repairs, respectively. The curves for both series of tests show that the PSeven linear elastic analysis software under-predicts the field performance of Rapid Set Concrete Mix[®], especially with Series 5. The coefficient of determination, or R^2 , for the Series 1 data was much higher than the R^2 for the Series 5 data, indicating a better performance prediction for Series 1. The lower R^2 value for the Series 5 performance curve was not surprising due to the segregation near the surface of the Rapid Set Concrete Mix[®] cap for Repair 15 and the early failure of Repair 17. The Series 5 repairs, particularly Repairs 15 and 17, should be repeated to validate the unanticipated data.

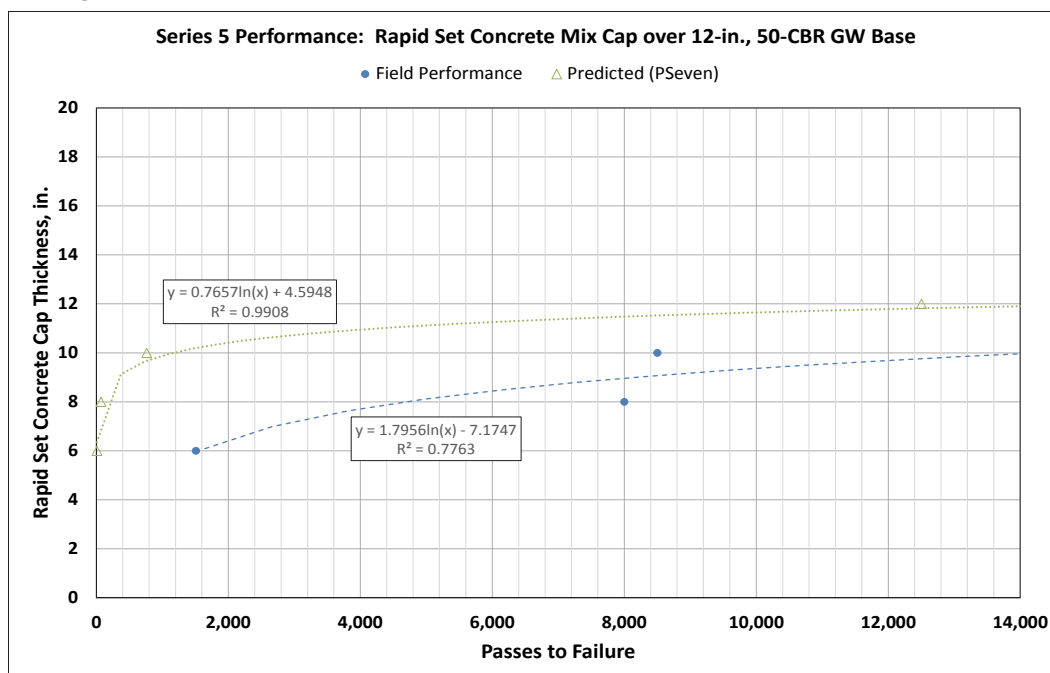
Figure 38. Series 5 field performance and predicted Rapid Set Concrete Mix® Curves.

The theoretical passes to failure increased by approximately one order of magnitude for every 2-in. increase in thickness of concrete surface between 6 and 10 in. thick, which was not the case for the field measurements. For a 6-in.-thick Rapid Set Concrete Mix® cap over any of the backfill conditions examined in this project, current pavement design theory indicates only approximately 10 passes can be achieved prior to structural failure (shattered slab). Field performance shows that even with a 6-in.-thick cap over a weak subgrade (Repair 1), several hundred passes can be applied prior to functional failure of the repair caps (spalling). The theoretical prediction for the 8-in.-thick rapid-setting cap over any of the backfill conditions evaluated in this project was approximately 70 passes of the F-15E aircraft, while the theoretical prediction for the 10-in.-thick caps was approximately 700 passes. The field performance for the 8-in.-thick caps was at least 25 times higher than the theoretical prediction, and the field performance of the 10-in.-thick caps was at least 3 times higher. The theoretical prediction for the 12-in.-thick cap over a weak subgrade (Repair 4-2), however, matched the field performance, while the 14-in.-thick cap of Repair 5 -2 was underpredicted.
